NPDES Inspection Report

Storm Haaven Farm Lyden, WA 98264

Jon Klemesrud
Environmental Protection Agency, Region 10
Office of Compliance and Enforcement
Inspection and Enforcement Management Unit

February 24, 2012

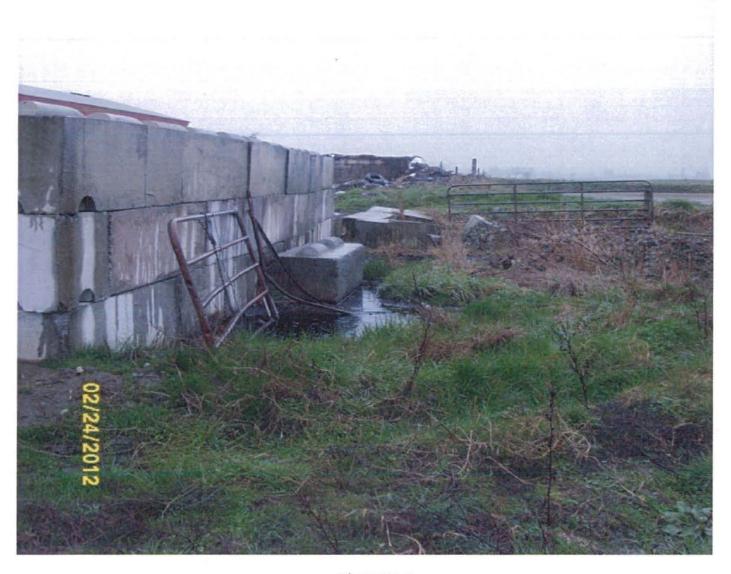
A. <u>Solid Storage Containment Area</u>: At the time of inspection the facility's solid storage area appeared to be full and near maximum capacity. I observed liquid seeping from the south end of the containment area, mixing with stormwater, and entering a grass field south of the containment area. The water ponded in the grass field roughly 150 from the unnamed ditch.

The liquid seeping from the solid storage area was flowing in a southerly direction towards an unnamed ditch. The unnamed ditch connects with Jackman Road ditch and ultimately connects with the Nooksack River. The unnamed ditch is roughly 350 ft from the solid storage area. No discharge to the unnamed ditch was observed during the inspection.

Photo No. 1
Photo facing East, showing the back end of the solid waste containment area. I observed liquid leaving the containment area from the south end and entering the grass field shown above.

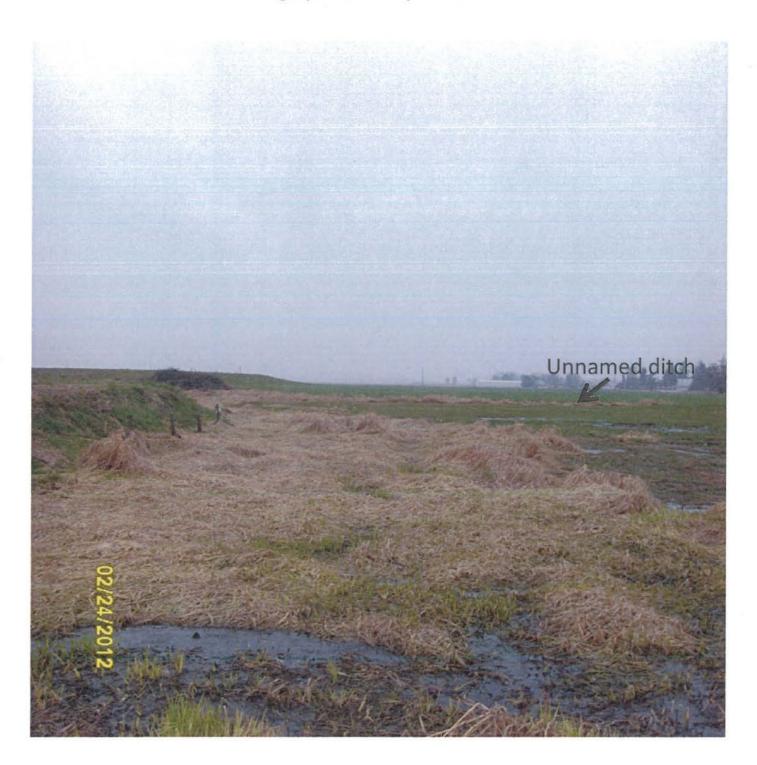
Photo No. 2

Photo from the south end of the solid storage area facing south toward the unnamed ditch. The liquid shown in the photo was the seepage seen leaving the containment area as well as stormwater.

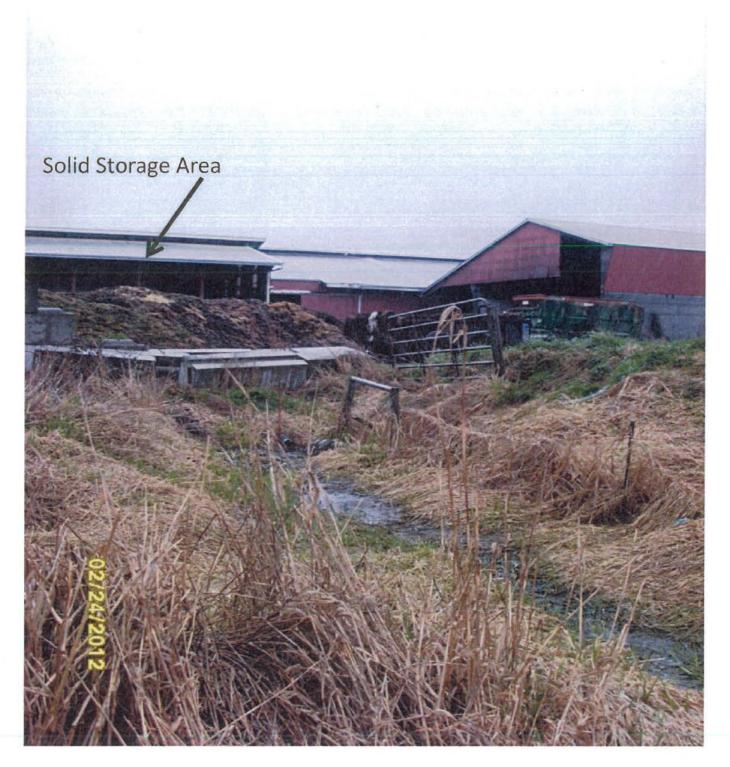
Photo No. 3

Photo facing North, looking towards solid storage area. The liquid shown in the photo was the seepage seen leaving the containment area as well as stormwater.

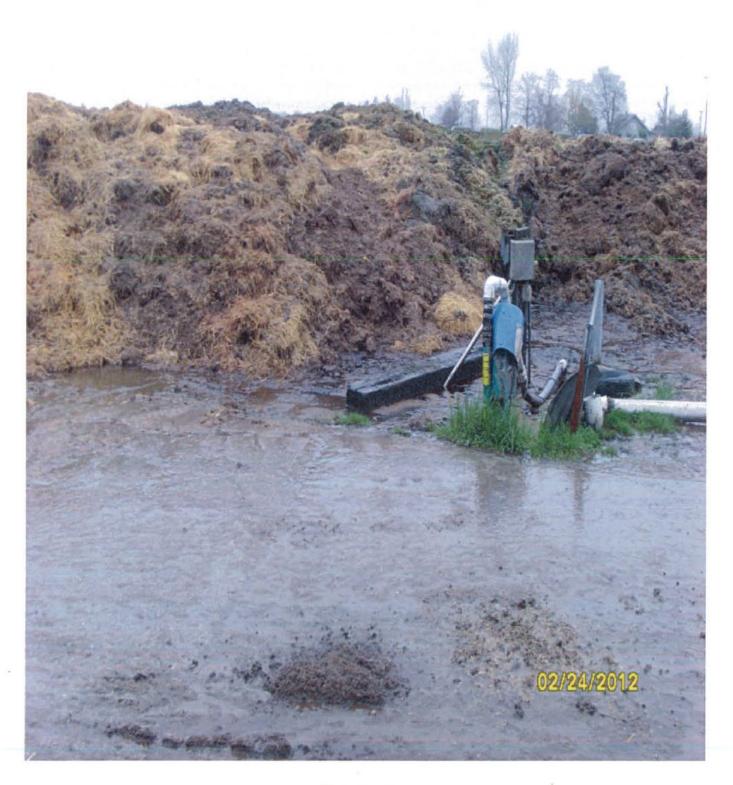
The solid storage area was uncovered and exposed to stormwater at the time of inspection. The solid storage area's structure consists of a series stacked concrete blocks and it's paved surface generally slopes north away from the grass field to a catch basin. The catch basin is designed to capture all runoff coming from the solid storage area, however, due to the amount of solids, it appeared that not all of the liquid was being routed to the catch basin.

Photo No. 4
Photo facing South, showing solid storage area as well as catch basin and pump designed to capture liquid runoff and route to storage lagoon.

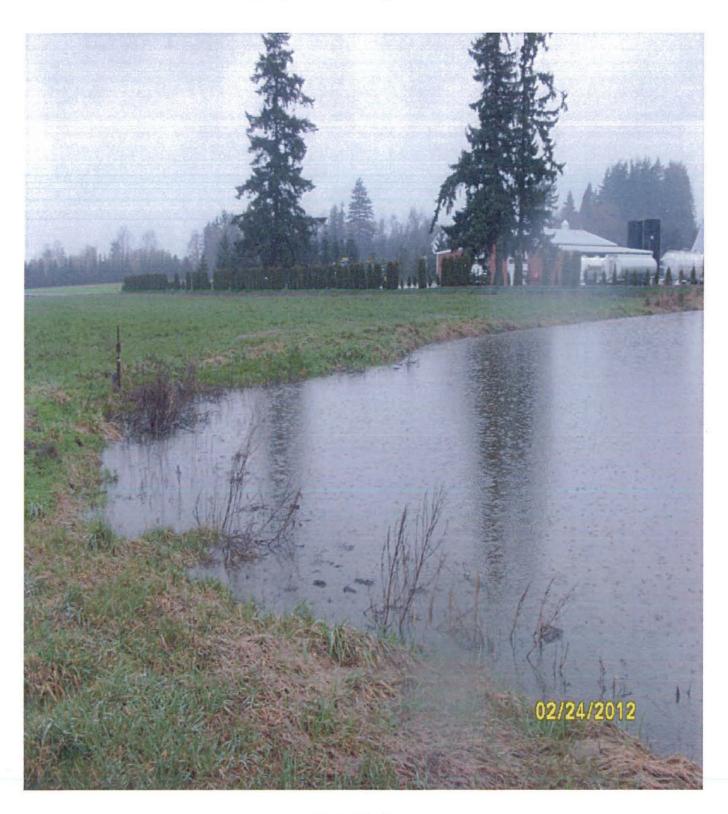
B. <u>Heifer Barn Lagoon Capacity:</u> At the time of inspection the facility's 1.5 million gallon waste storage lagoon at the heifer barn location was near maximum capacity. This lagoon sits elevated about 80ft from an unnamed drainage ditch. See Attachment B, Photo #5 to see the lagoon at the time of inspection.

Photo No. 5 Photo facing Southwest, showing the heifer barn lagoon at the time of inspection.
